Textile Preservation Associates, Inc.

TREATMENT REPORT

TPA No. 1105
Object Galveston 2nd Nat'l.

Client Texas State Archives
P. O. Box 12927
1201 Brazos Street
Austin, TX 78711-2927

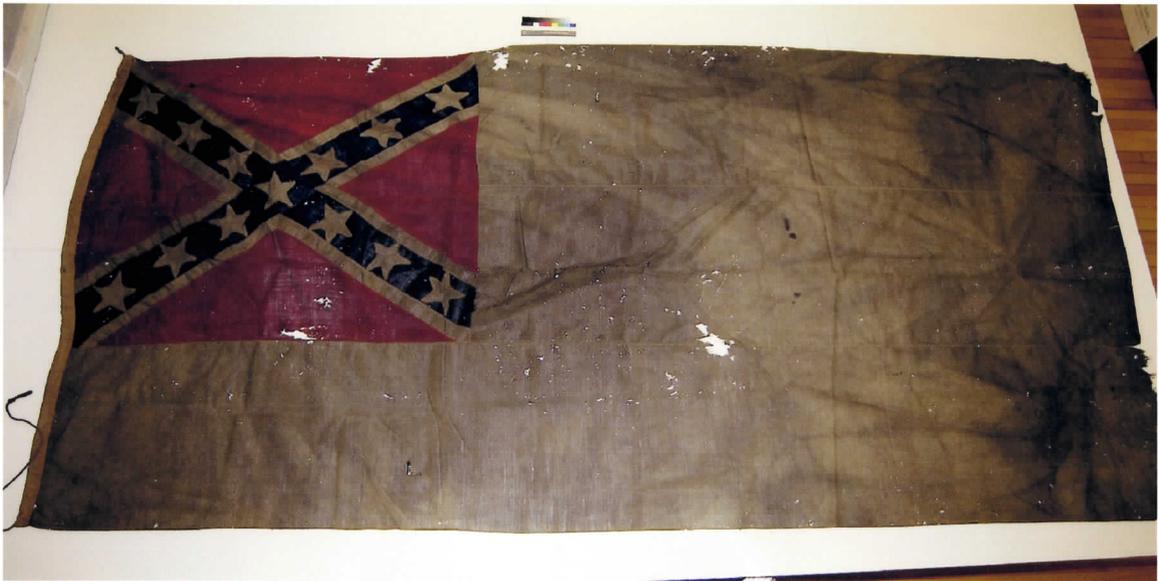
TPA #1105
As received, obverse

The flag is intact except for a 1" section of the hem on the fly end of the bottom bar. There is a 3" x 4" hole in the center of the fly near the bottom seam and a 2" square hole along the top edge 2" from the canton. There is a 1" x 2" hole on the top edge of canton and another hole in the bottom quadrant of canton. There is a series of smaller holes along the center of the top edge and in the center of the fly. The flag is extremely soiled throughout. The wool is brittle and degraded. The hoist edge has a 1" burn hole in the center.
