## TREATMENT REPORT

TPA No. 1073  
Object 5th Texas Hood's Brigade  
Cat. No. M-29-80

Client Texas State Archives  
P. O. Box 12927  
1201 Brazos Street  
Austin, TX 78711-2927

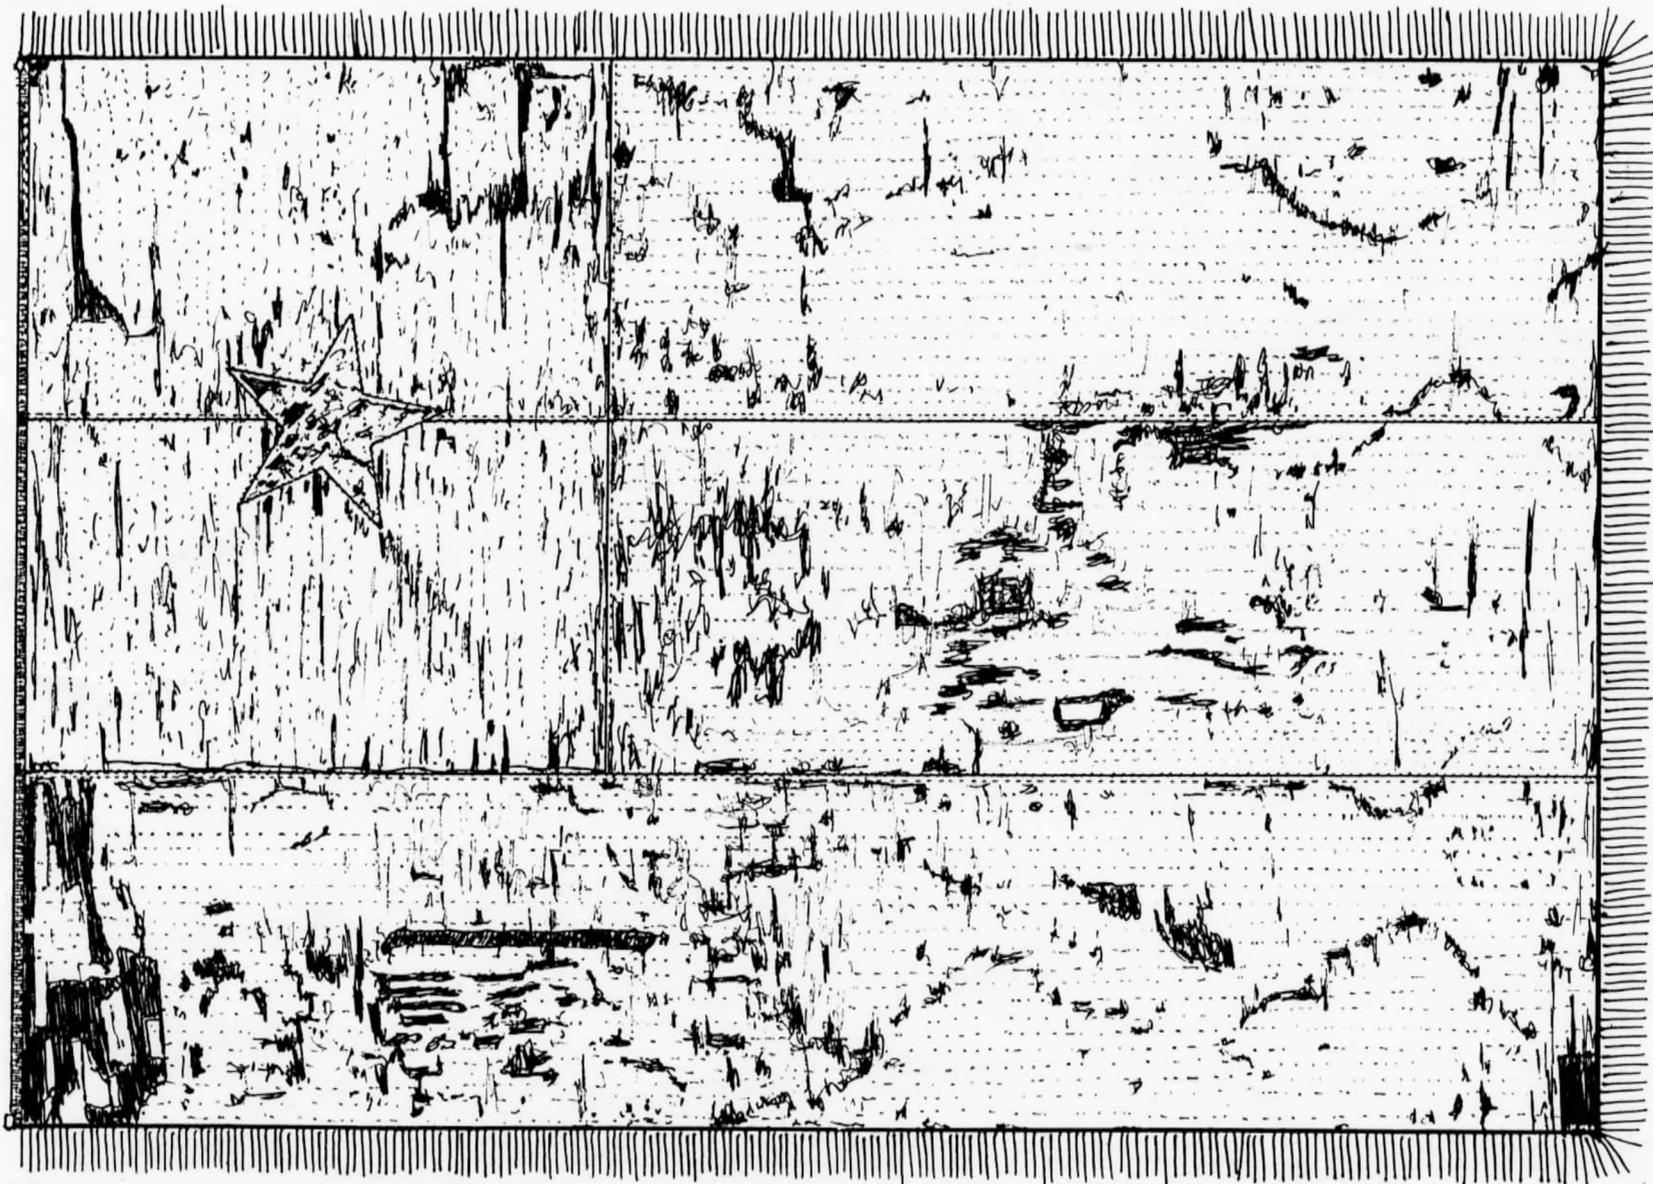
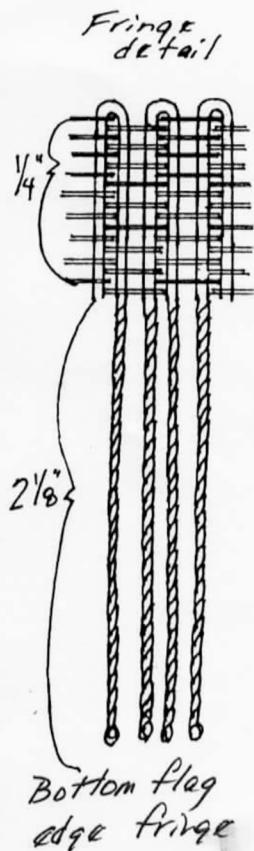
Drawing # 3  
CONDITION

The canton has multiple vertical splits and is very weak. The previous treatment left the canton totally separated from the fly. The star on the obverse side of the canton is fragmented with some loss. The star on the reverse is mostly intact. The bars are severely damaged with multiple holes and splits throughout. Many of the holes appear to be the result of insect damage. There are several stains and tide lines in the fly. There is considerable breakage along the tide lines, especially in the red silk. There is a 4" by 3" section of the bottom corner missing along with 7" of the fringe. The bottom hoist corner has suffered some loss including 3" of fringe. There is a 12" section of fringe missing at the top fly end. There is approximately 1" to 2" missing from the fly end including the fringe. The seam between the two bottom bars is complete. The previous treatment has left a pattern of tiny holes and wrinkling throughout. The binding on the hoist is weak and one element of the weave has deteriorated leaving only strands. The two ties at the center of the flag are completely missing along with a fragment of the leading edge. The top and bottom ties have only fragments remaining. The silk is badly faded throughout. The traditionally red silk bars appear violet in color. There is no evidence that they were originally red. A purple hue may have been the original color.
