TREATMENT REPORT

TPA No. 920

Object 1st Regiment Texas Vol. Infantry, Hoods 3rd bunting

Catalog No M-76-81

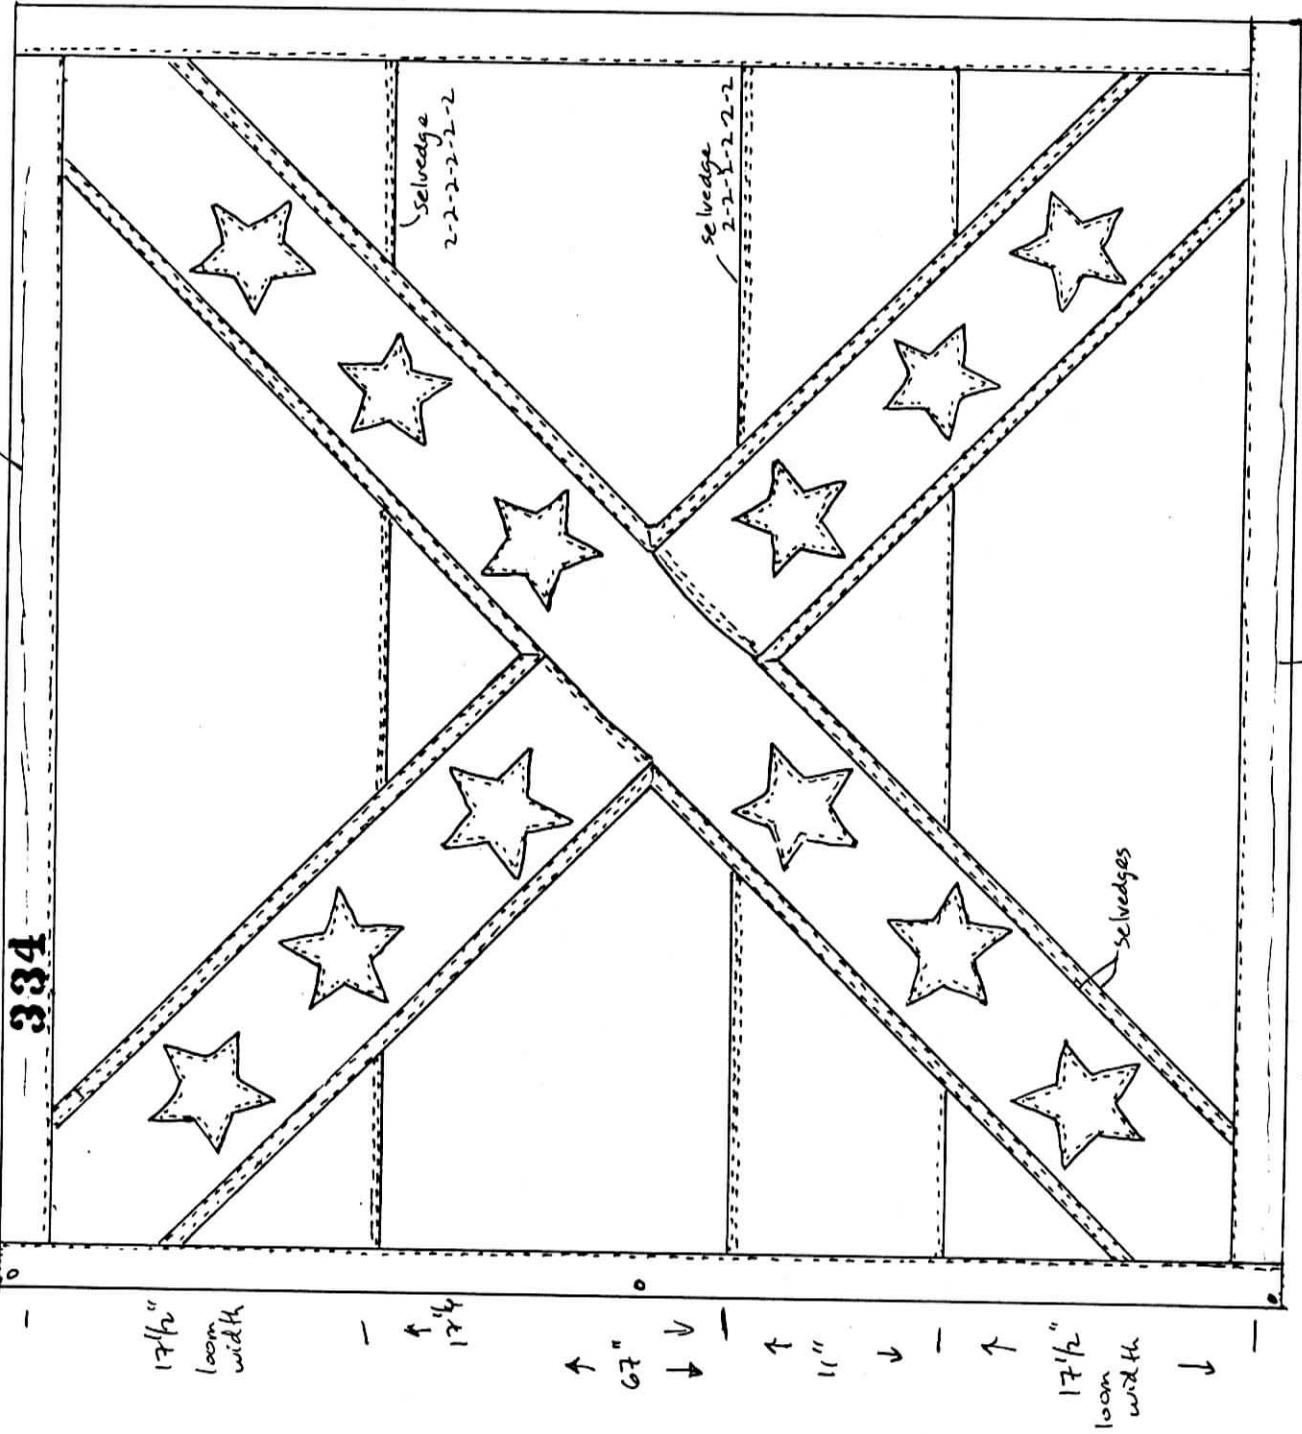
Diagram 3

1st Regiment Texas Vol. Infantry, Hood's 3rd Bunting
← 67" →
red selvedge under border

red selvedge encased in border

SELVEDGES

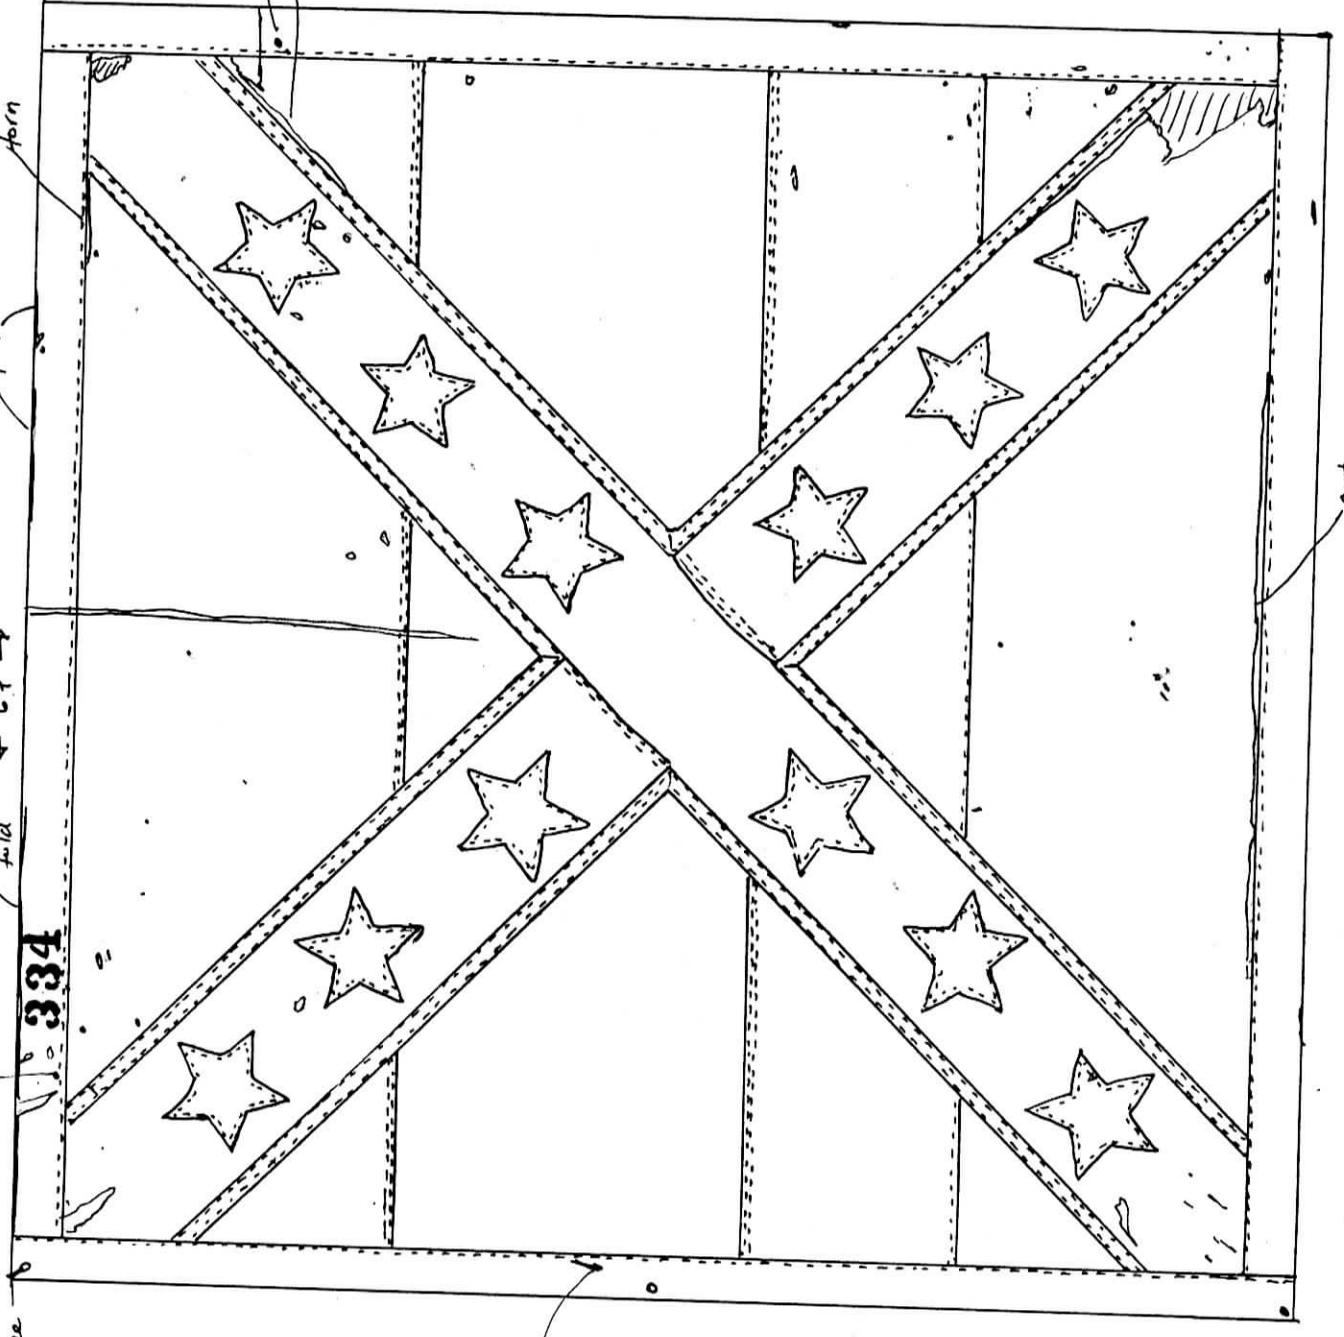
Diagram B

CONDITION

stain
↑ 67" ↓

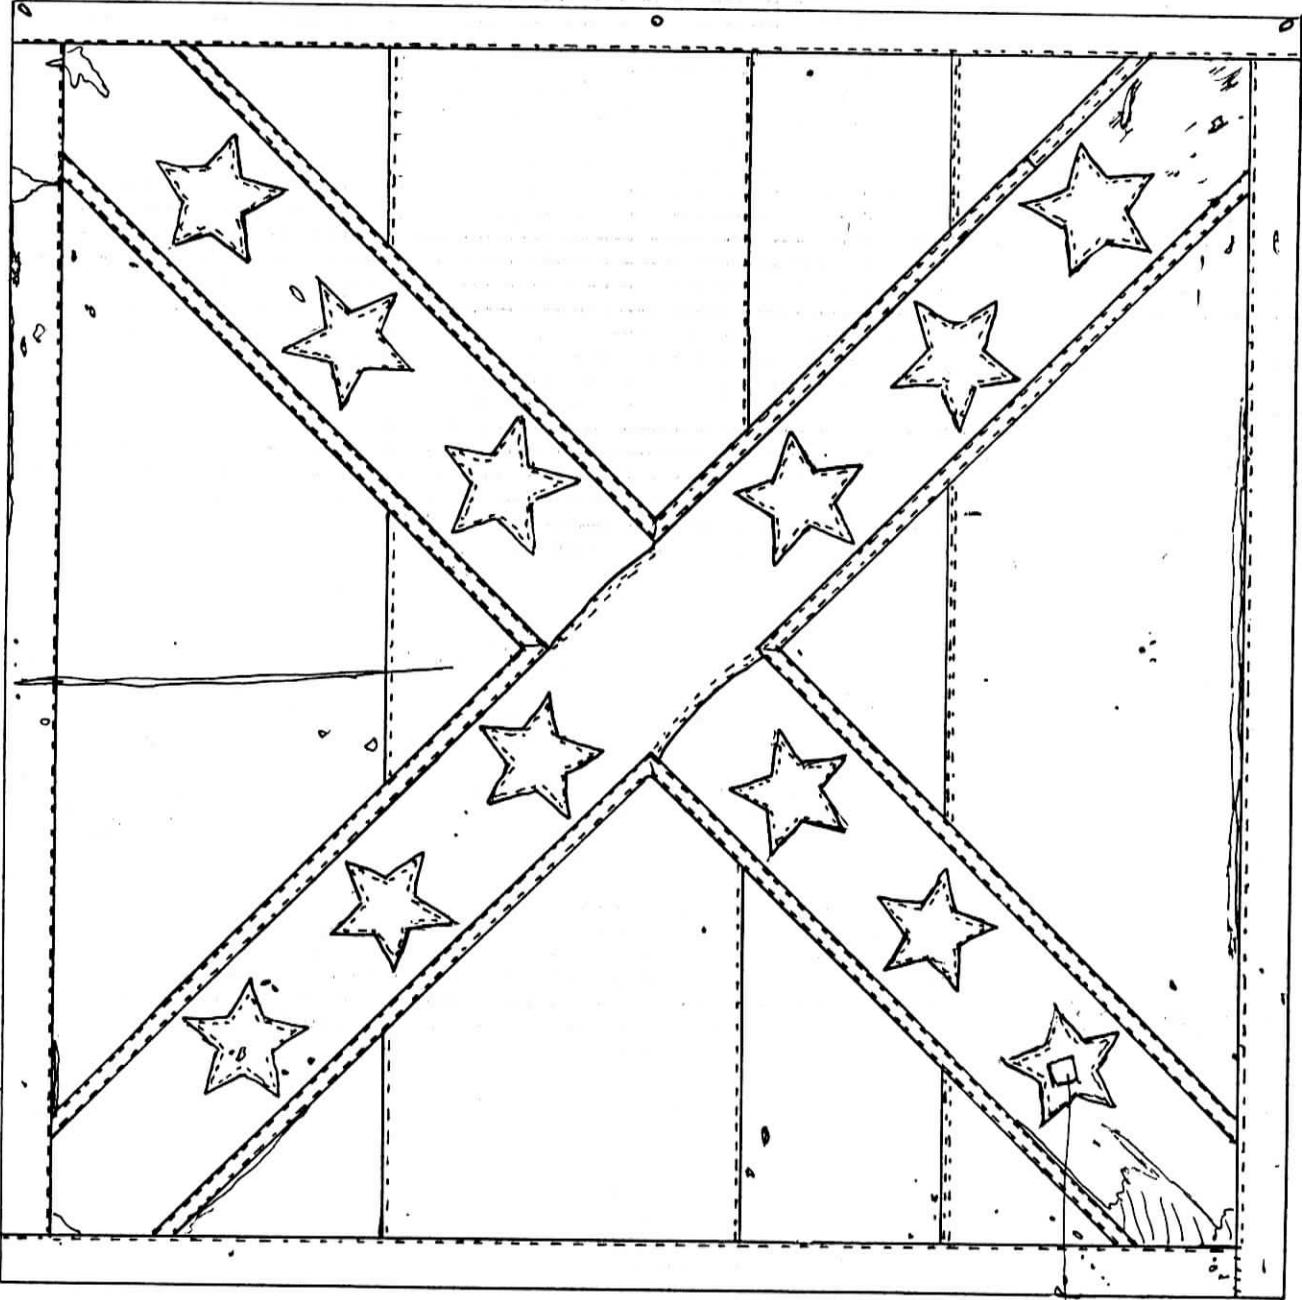
Diagram 9

CONDITION

paper +
adhesive
residue

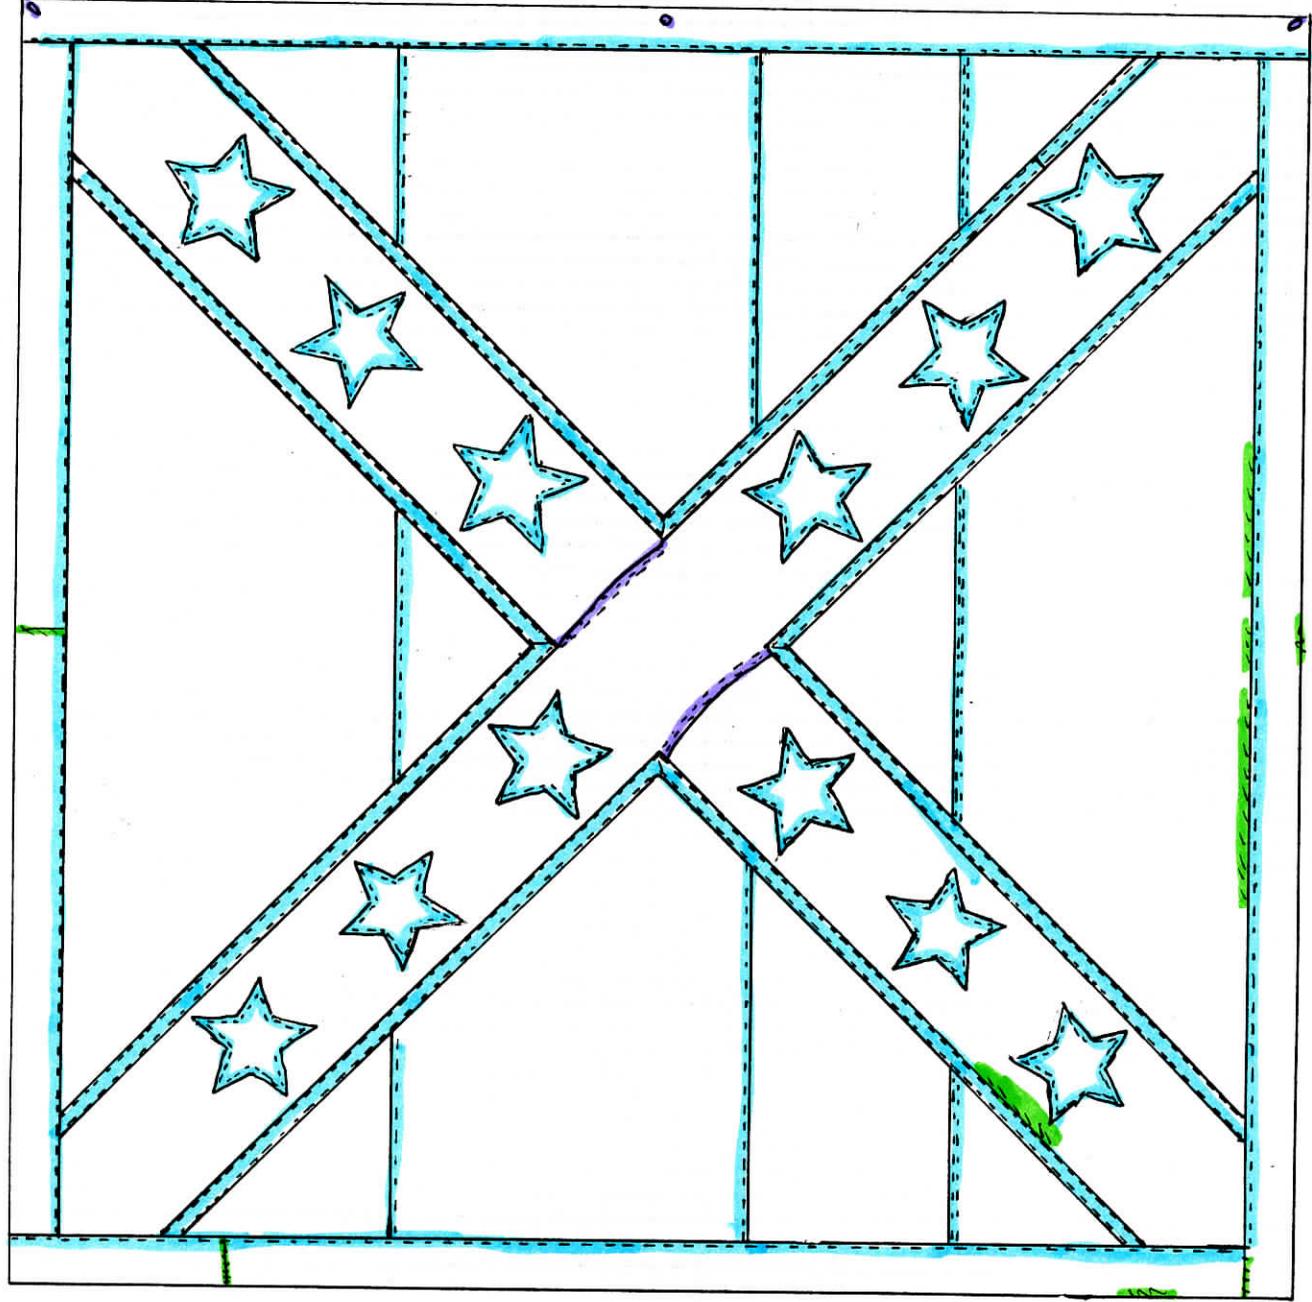
Diagram 6

- 3/2 S cotton
- 3 S cotton
- 3 Z cotton, mercerized
repair
(removed)
