Textile Preservation Associates, Inc.

TREATMENT REPORT

Object Guerrero Battalion flag

Catalog No M-5-80

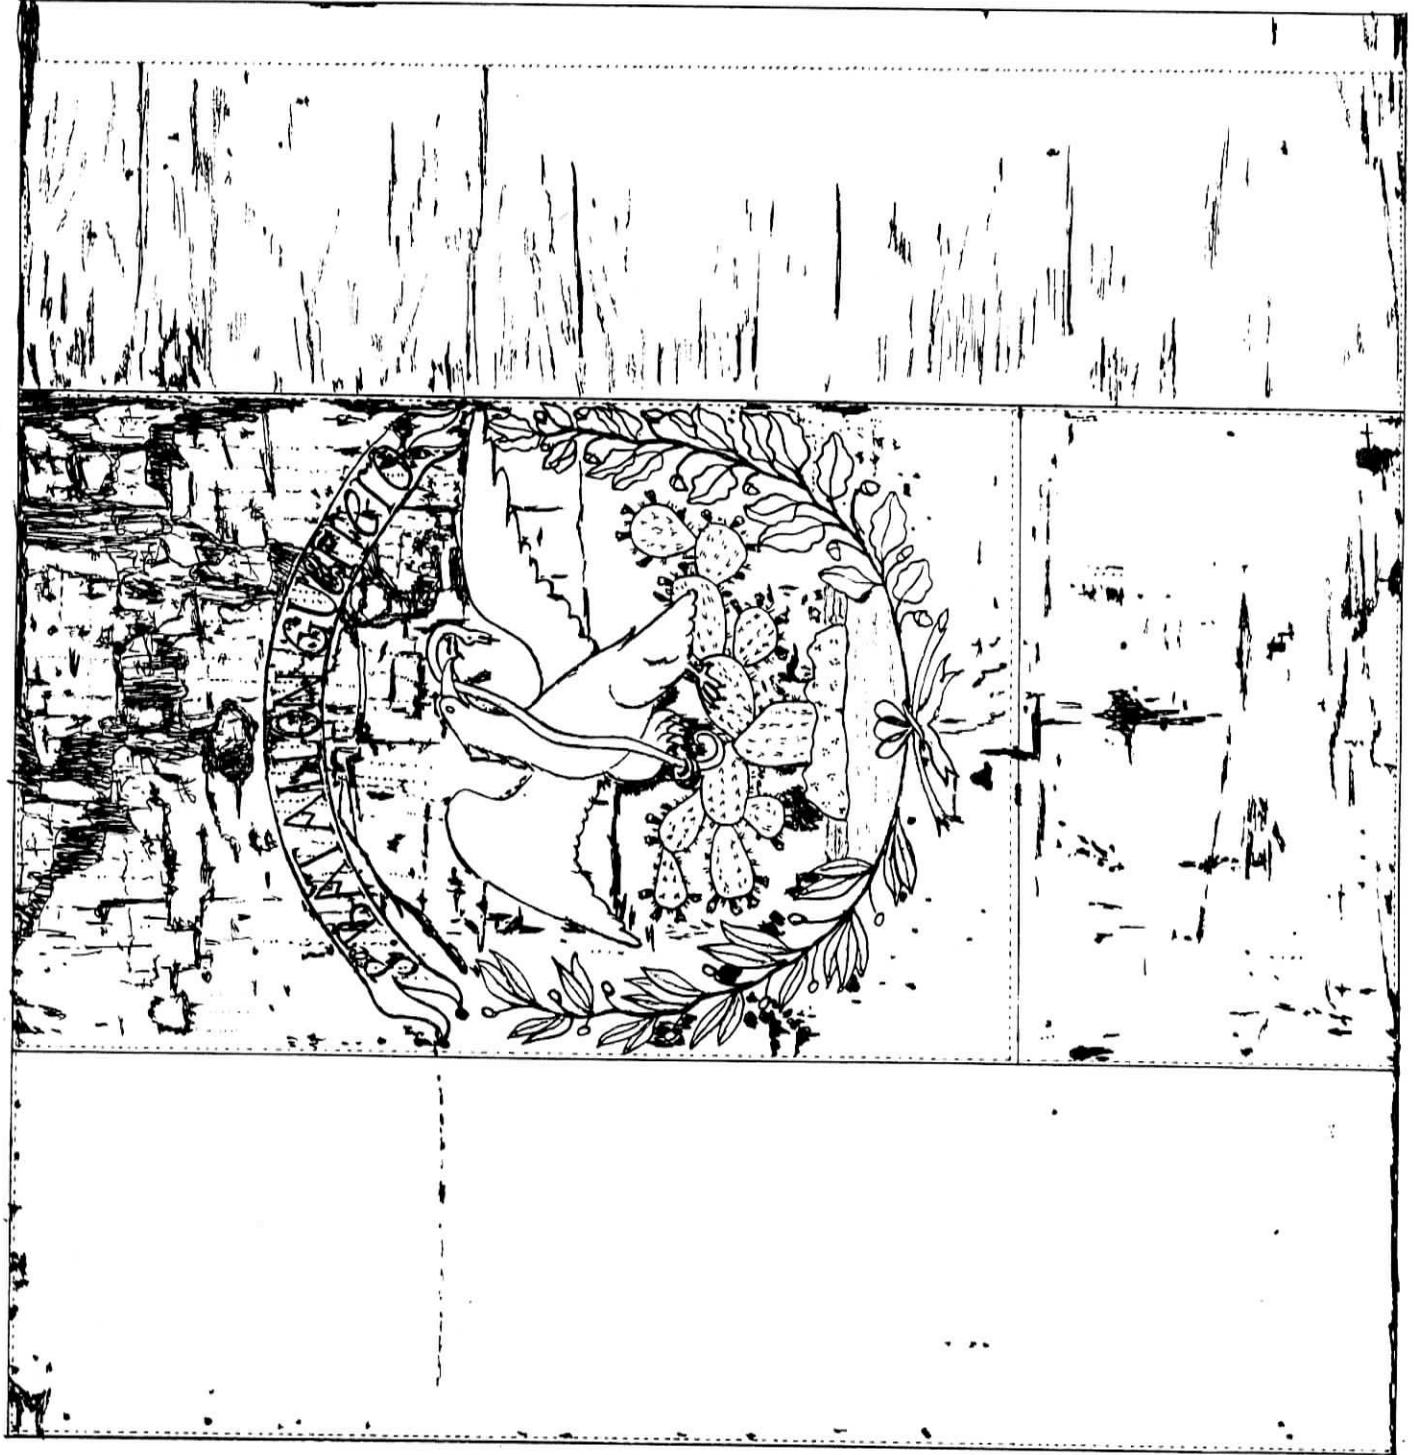
Drawing # 7

CONDITION

The red fabric is mostly intact with only tiny, 1/4" or less, holes throughout. The top edge which is the exception, has two 1" holes. There are also seven tack holes along the top edge. The green fabric is weak and badly faded. There are numerous horizontal splits throughout and a 1/2" to 1" section of the top edge is missing. The white fabric is badly fractured throughout with many detached pieces. Approximately 5% of the fabric in the area above the embroidery is missing. Some of the green dye has bled onto the white silk. The majority of the embroidery is intact but some areas have unraveled, especially in the word "Guerrero". The flag is soiled and stained throughout. Some of the stains tested positive for blood.

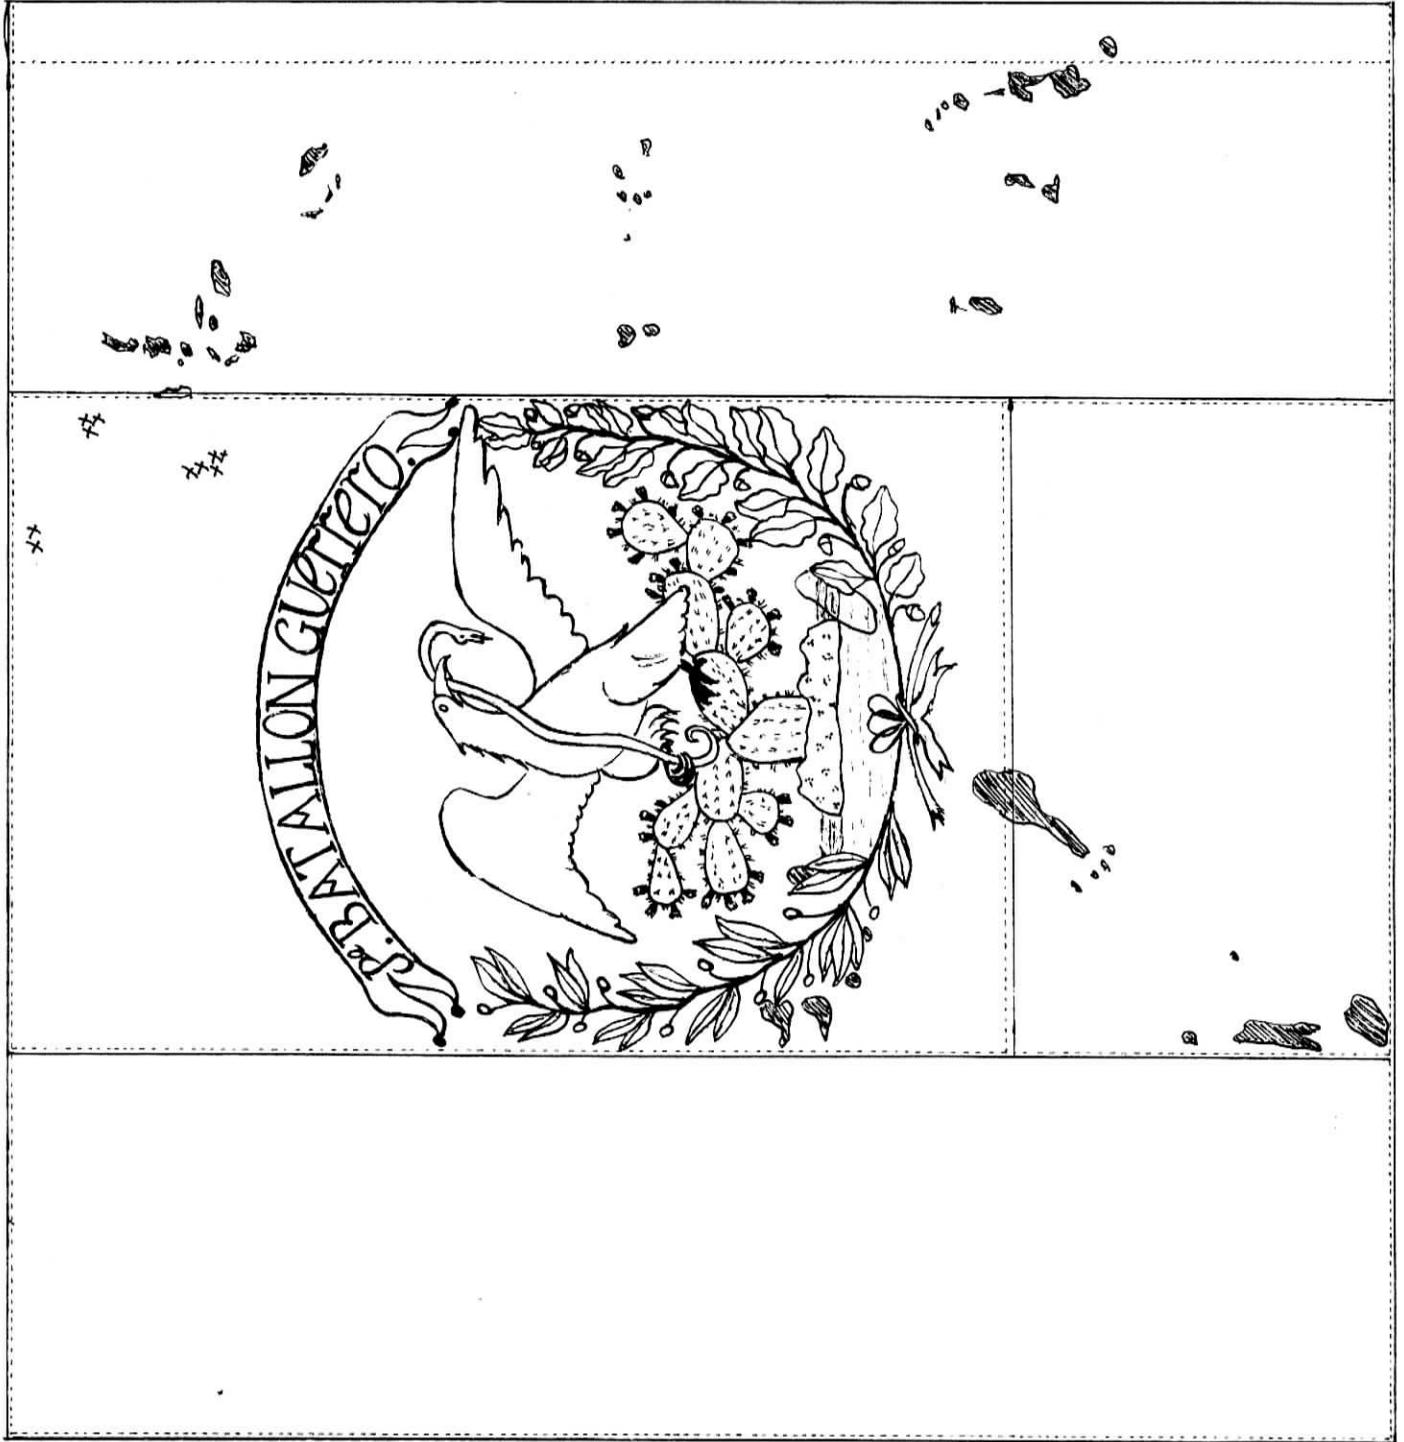
Drawing # 8

STAINING

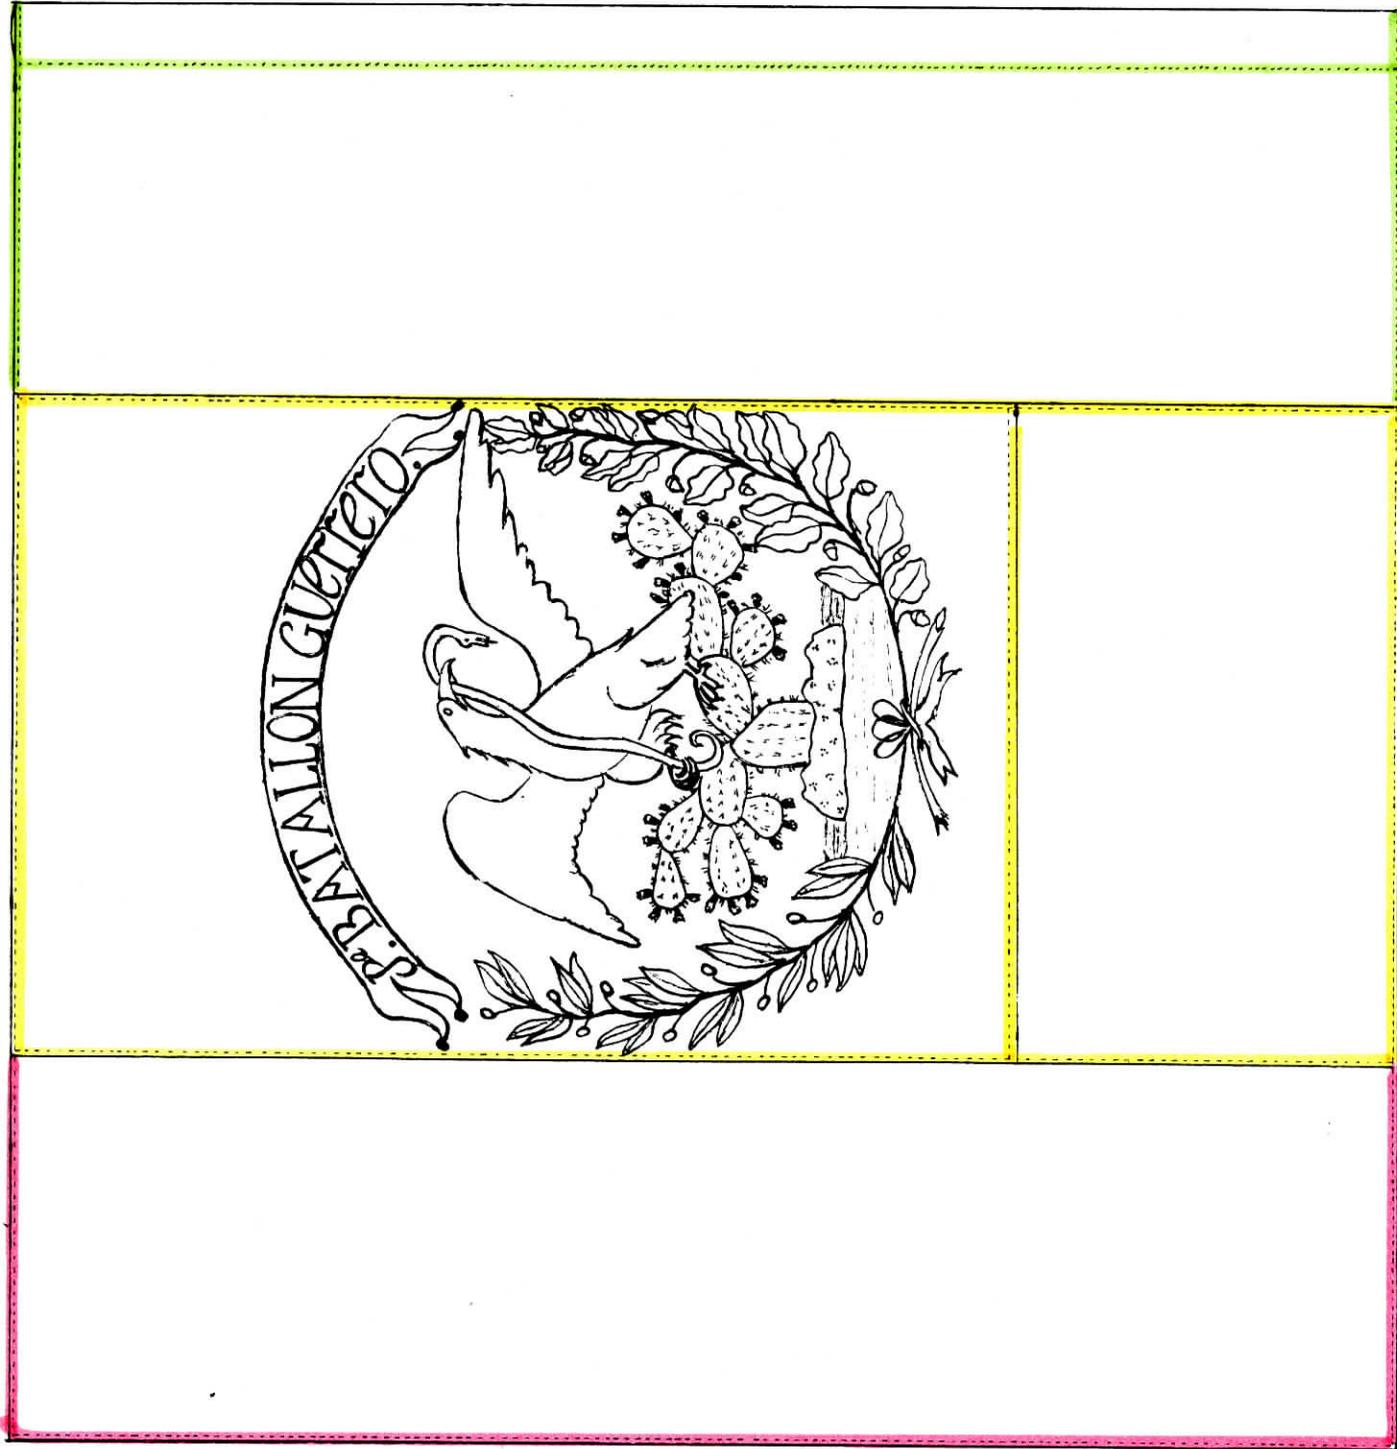
Drawing # 5

- 2 Ply S silk - RED
- WHITE
- GREEN (8/16)

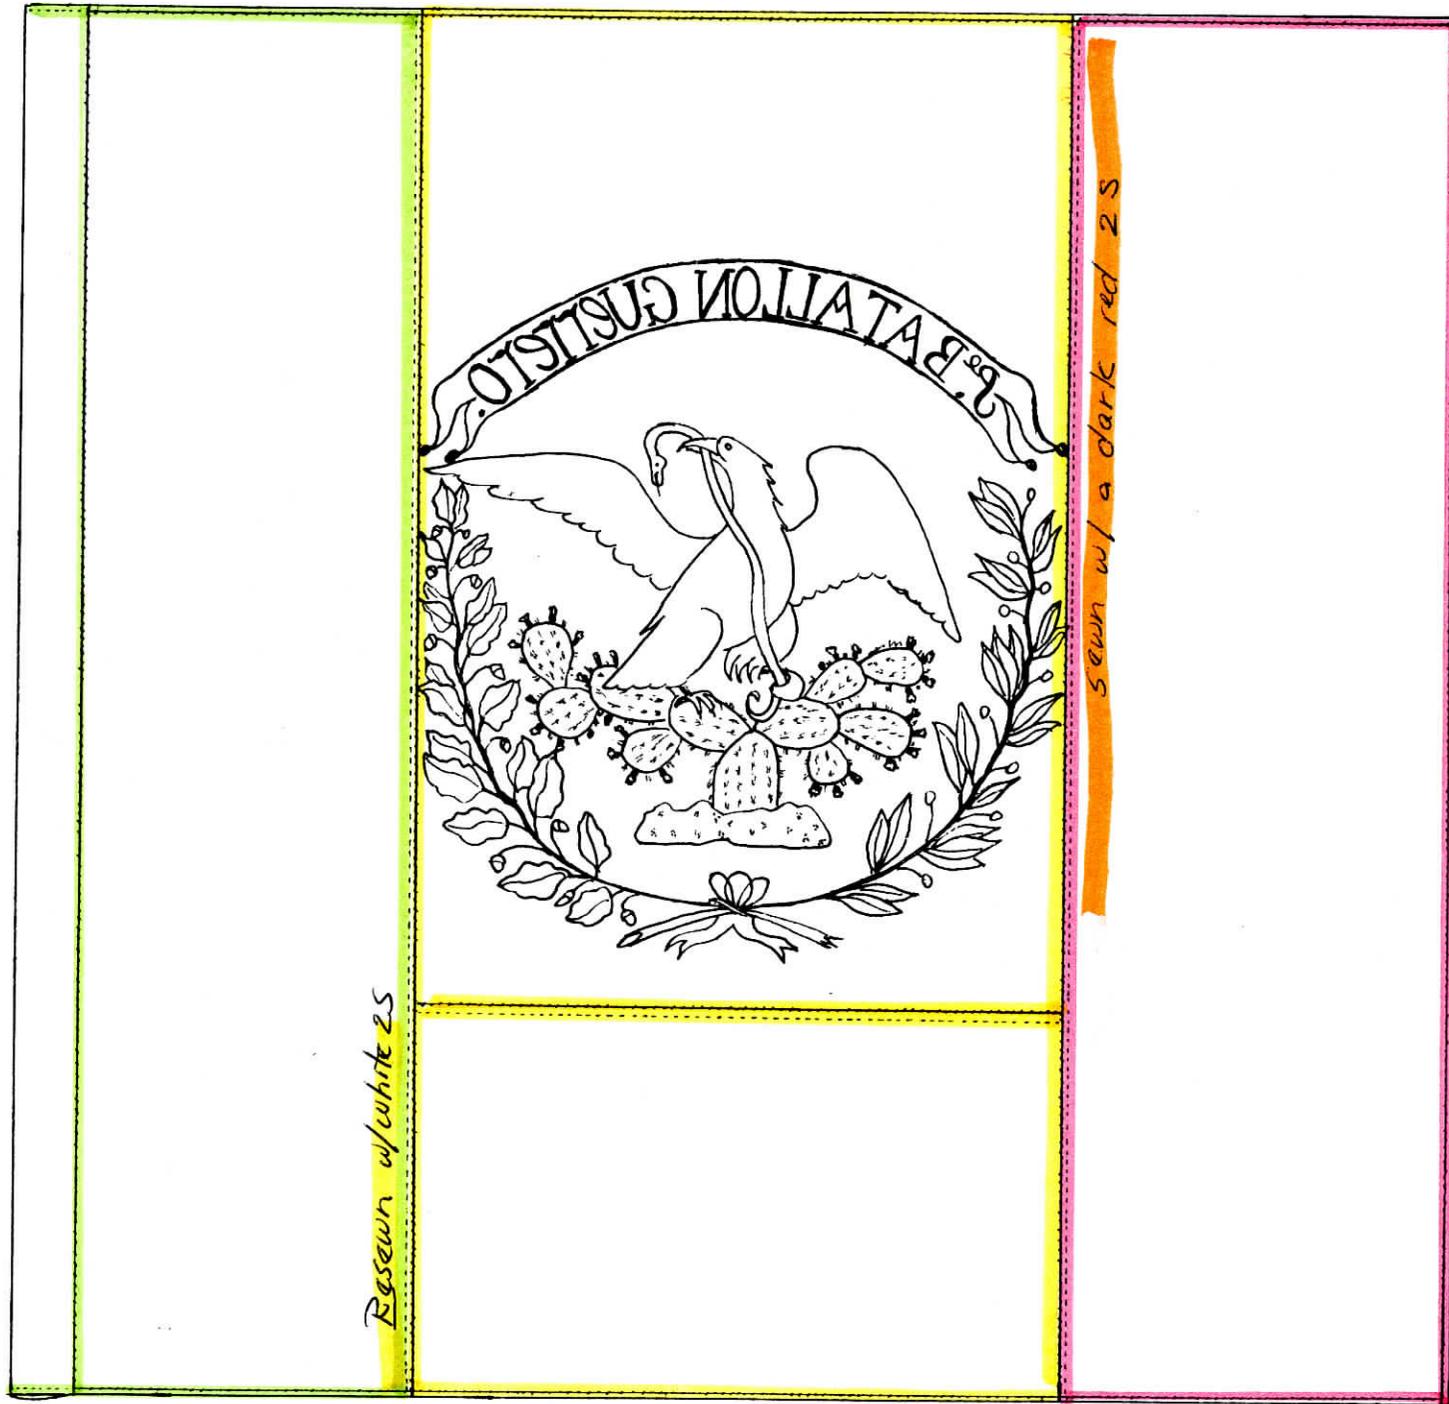
Drawing # 6
SEWING THREADS

2 Ply 5 Silk - RED
WHITE
GREEN (Blue)

Resewn w/white 25

sewn w/ a dark red 25
