Textile Preservation Associates, Inc.

TREATMENT REPORT

TPA No. 1072

Object Toluca Battalion battle flag

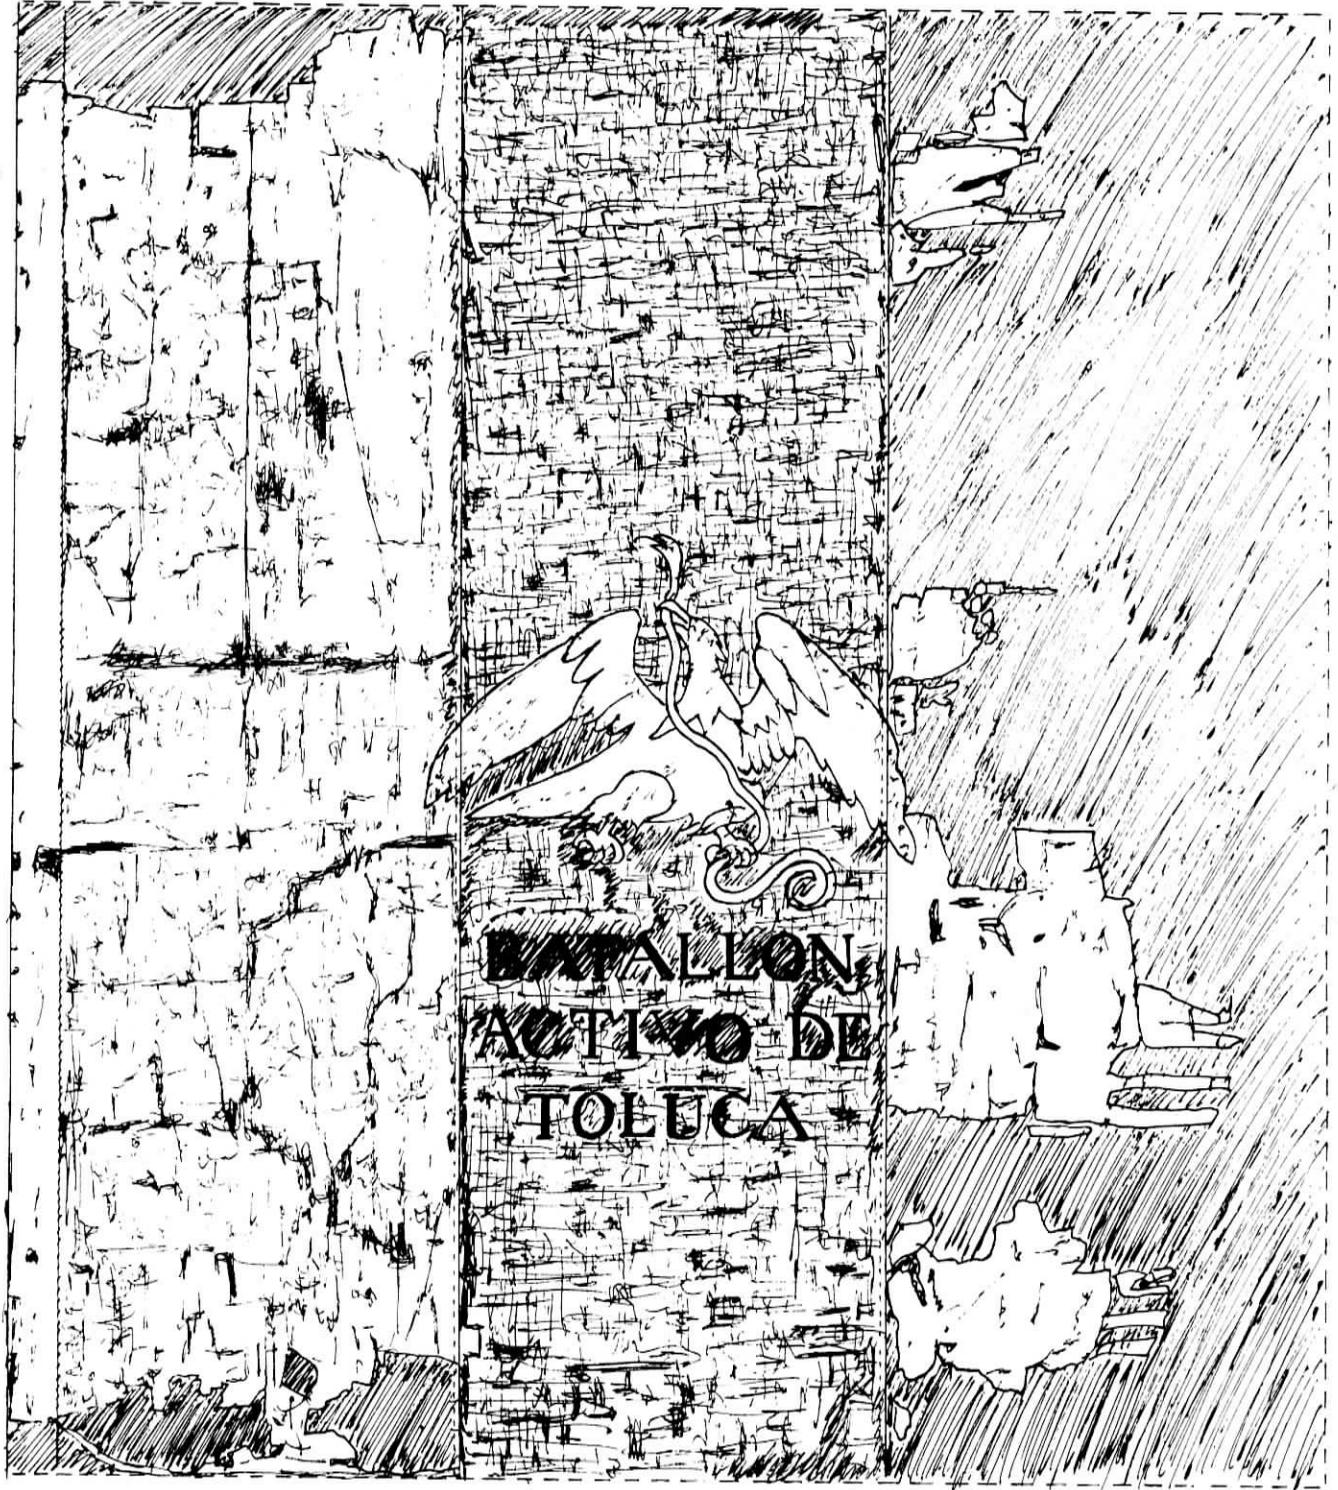
Drawing # 3
CONDITION

The previous treatments have caused considerable damage to the original silk of the flag. The machine stitching has left a pattern of holes through the fabrics and caused some breakage. The adhesive attaching the flag to the silk backing has hardened and is extremely brittle. Most of the fracturing, especially of the white bar, appears to be the result of the adhesive. The netting has left an impression on the silk, especially the green, and has abraded the flag in many places. There is approximately 80% of the green bar remaining but it is brittle and badly fractured. There is an estimated 6" portion at the top and bottom missing. The green silk is badly faded and the dye appears to be highly fugitive. The small amount of original silk remaining in the red bar is less brittle and fractured, but 85% is missing. The center (white) bar appears to be the most degraded. The silk that remains is extremely fragmented into mostly 1/4" size pieces and there is loss of approximately 30%. The white silk is brittle and will continue to fracture if handled. As described above, some of the embroidered letters have been

reconstructed. The original letters that remain are extremely fragile and powdering. The edges of the embroidered eagle have been severely damaged by the machine embroidery stitch that was applied around the perimeter. Some of the embroidery throughout the eagle is damaged with surface loss. All of the threads are extremely fragile.

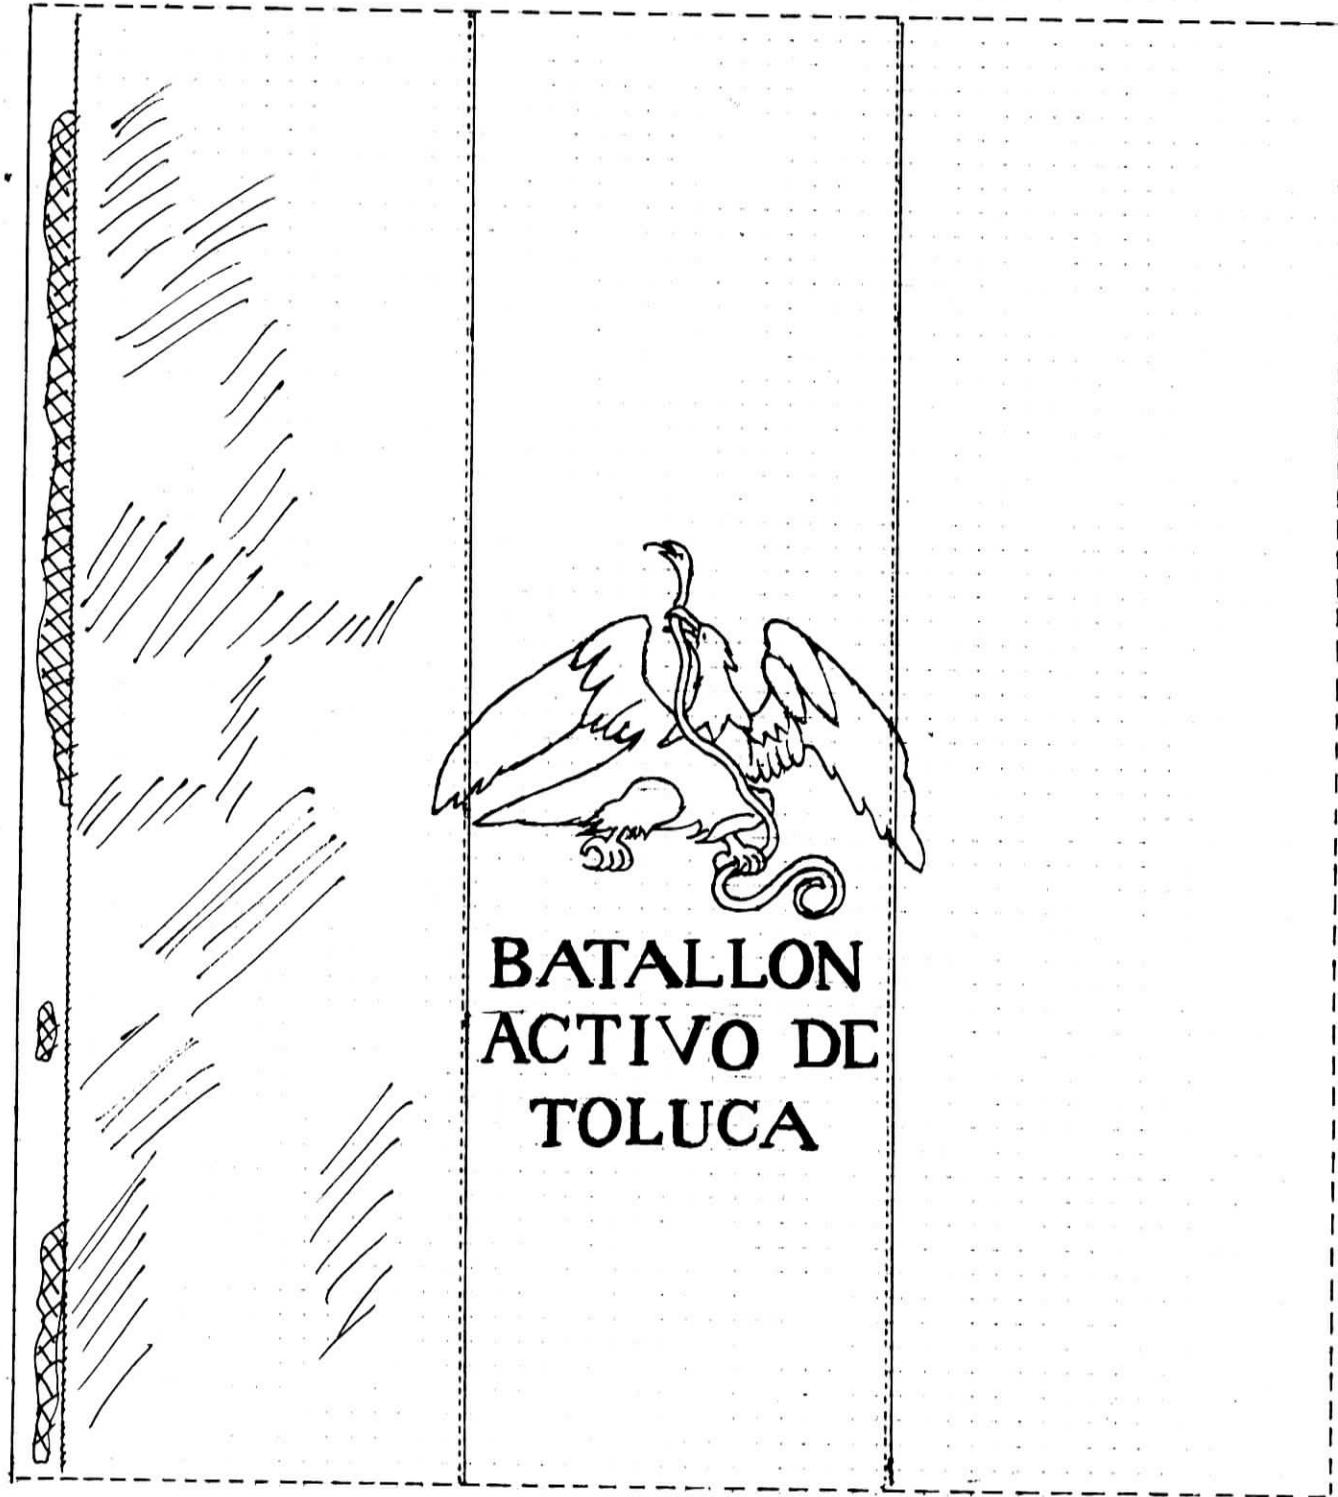
Drawing # 4

CONDITION
DAMAGE FROM
NETTING

Through top
layer of
pole sleeve
only

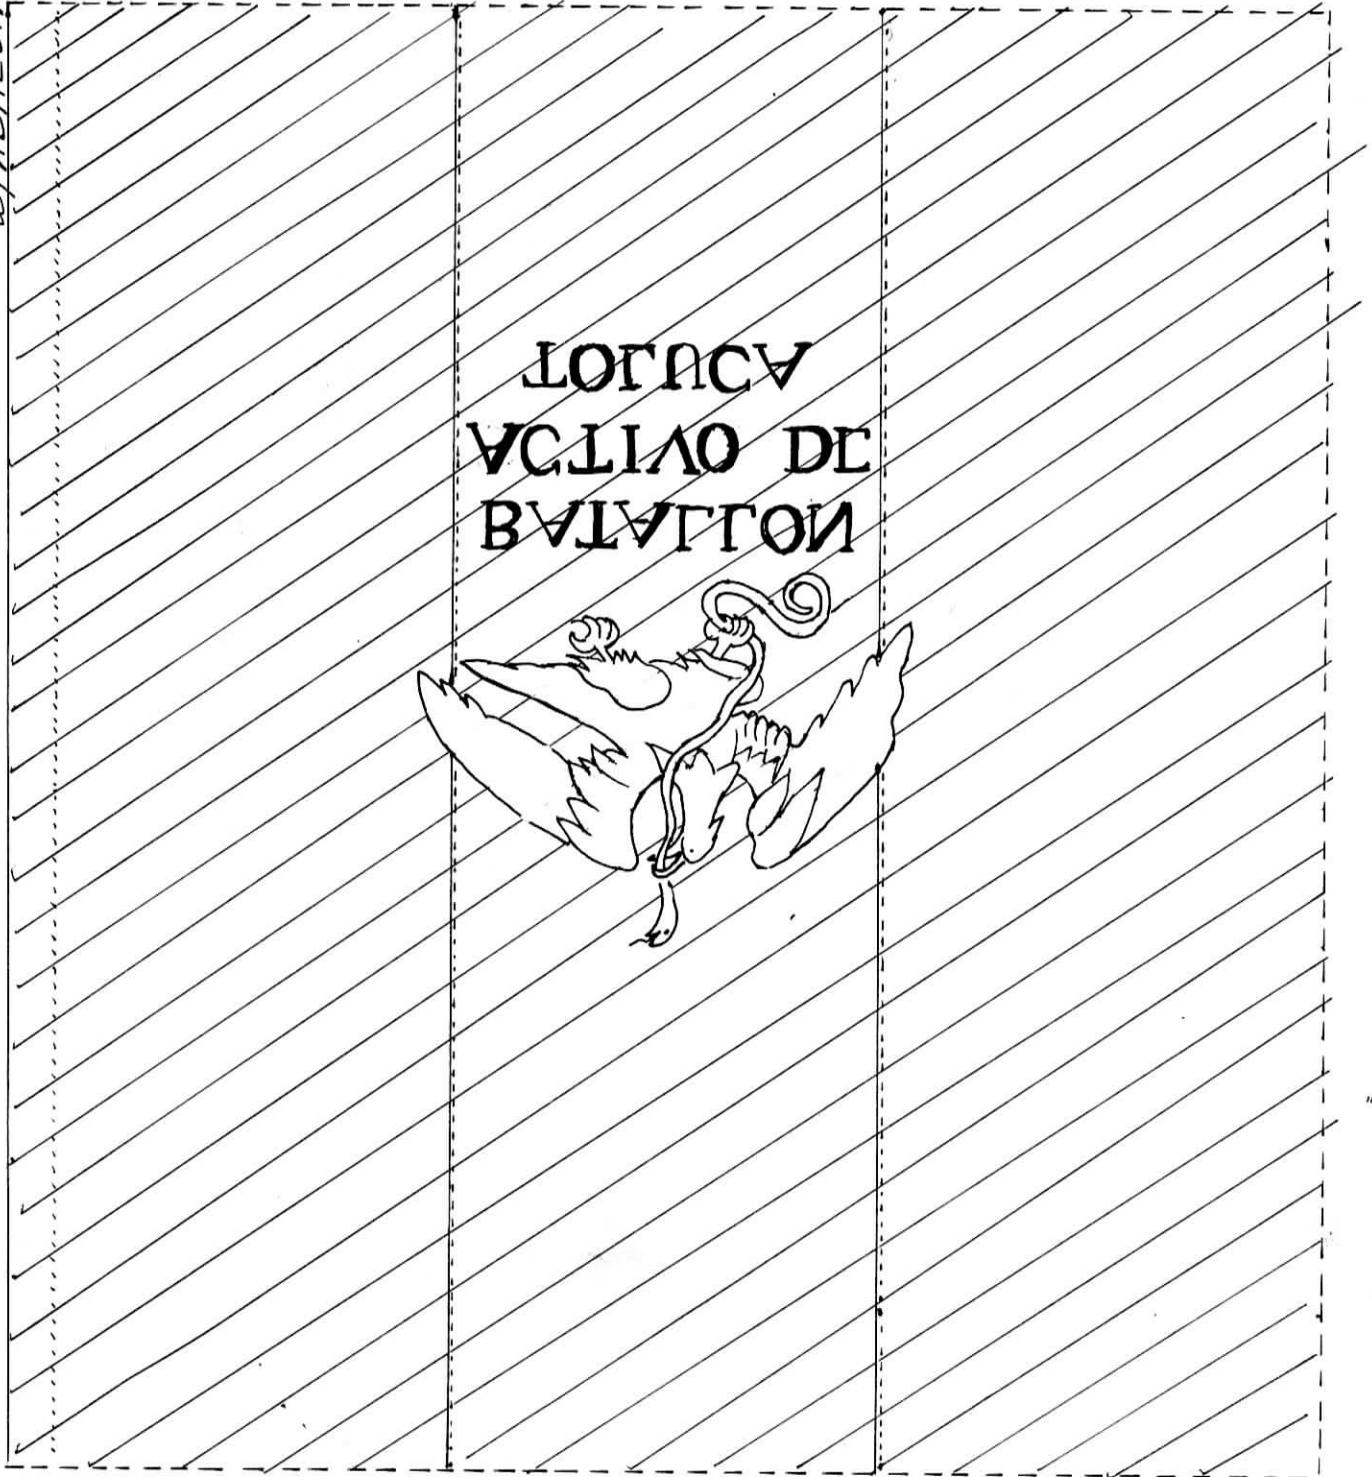
Drawing # 10

PREVIOUS TREATMENT
SILK BACKING
W/ADHESIVE

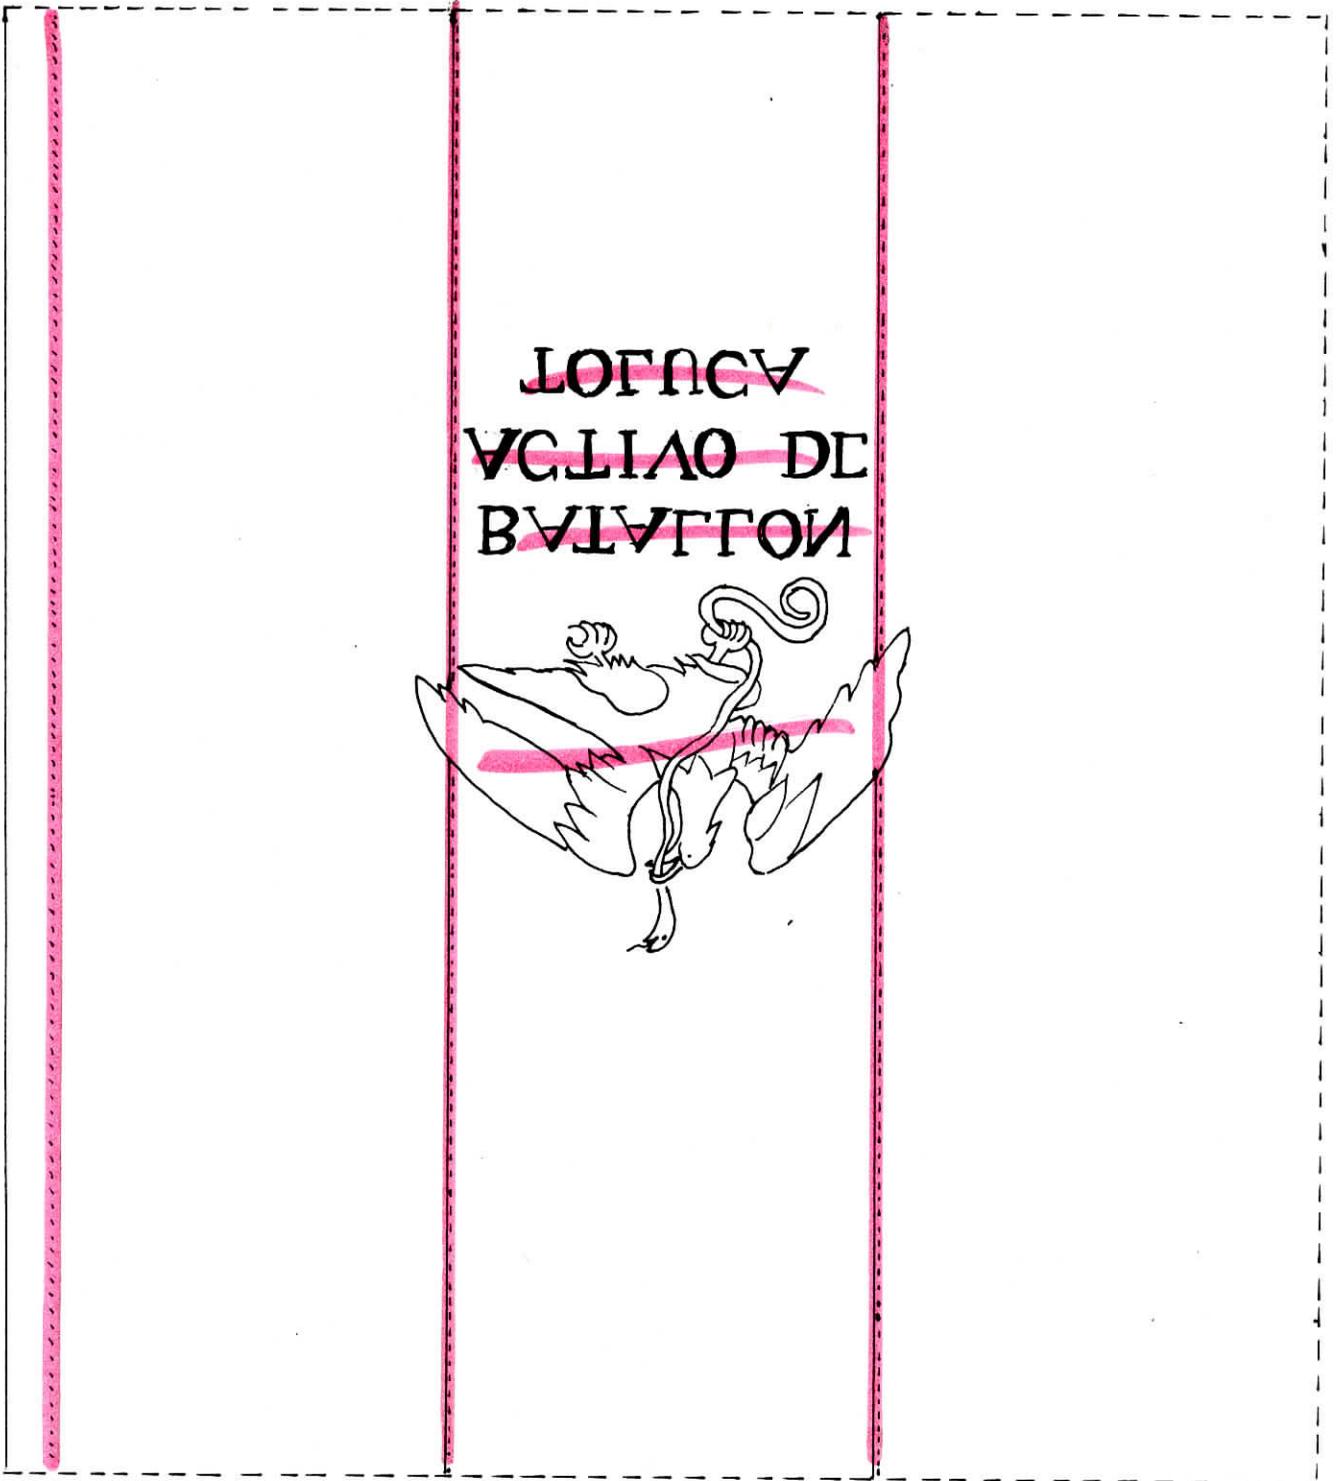
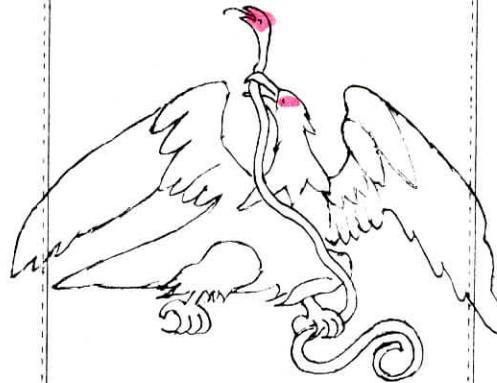
OBV RSE Drawing # 9

PREVIOUS RECONSTRUCTION
← 6" → LETTERING REPRODUCED
ENHANCED
