ITEM Confederate Flag UNSTABLE X

ACCESSION NO. 14 DATE 1/4/80 EXAMINER Beth Nelson

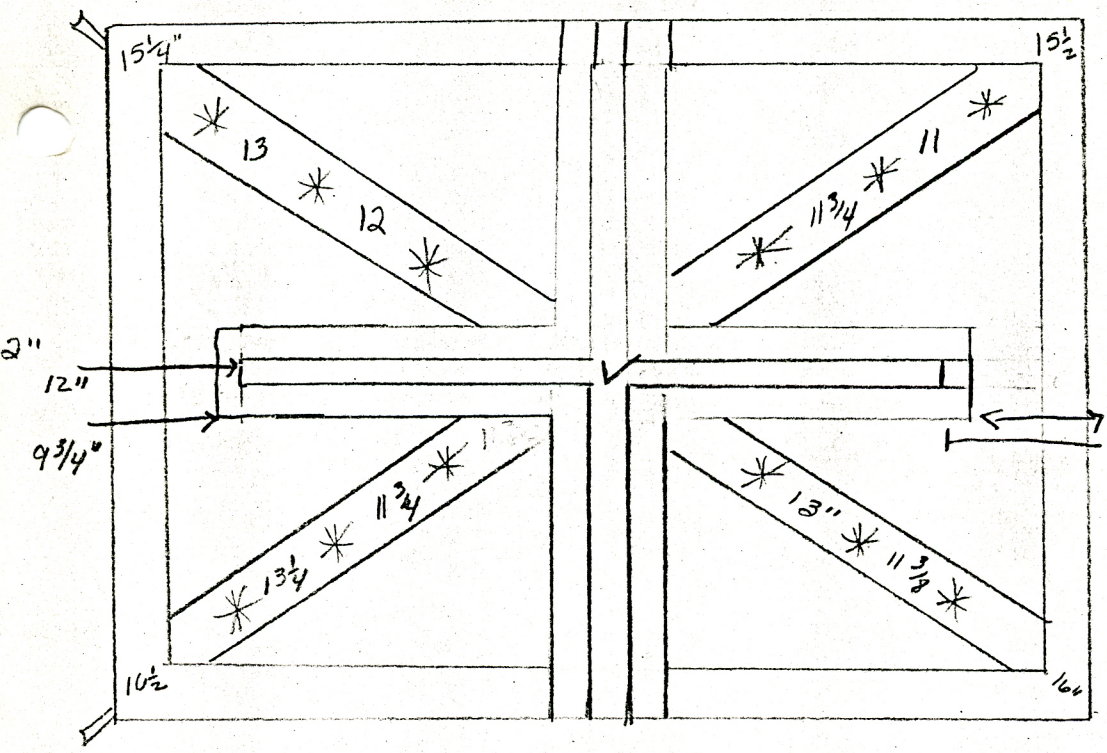
FACE

General: Poor
Specific: There are missing areas of the flag. The red cotton field is in pieces.

PREVIOUS RESTORATION: Red netting covers the entire face. Extensive stitching was done.

PROPOSED TREATMENT: Test a small area to see if the former restoration process could be reversed and done with a smaller thread.

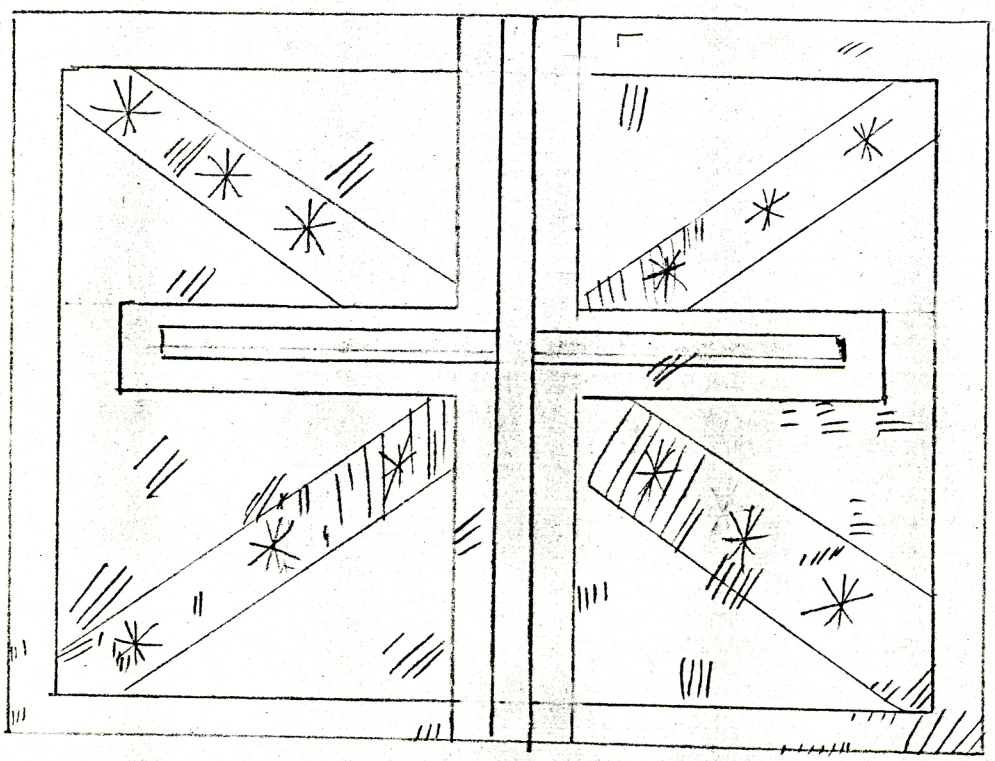
BOW WITH DARK ATTACHMENT

= missing area

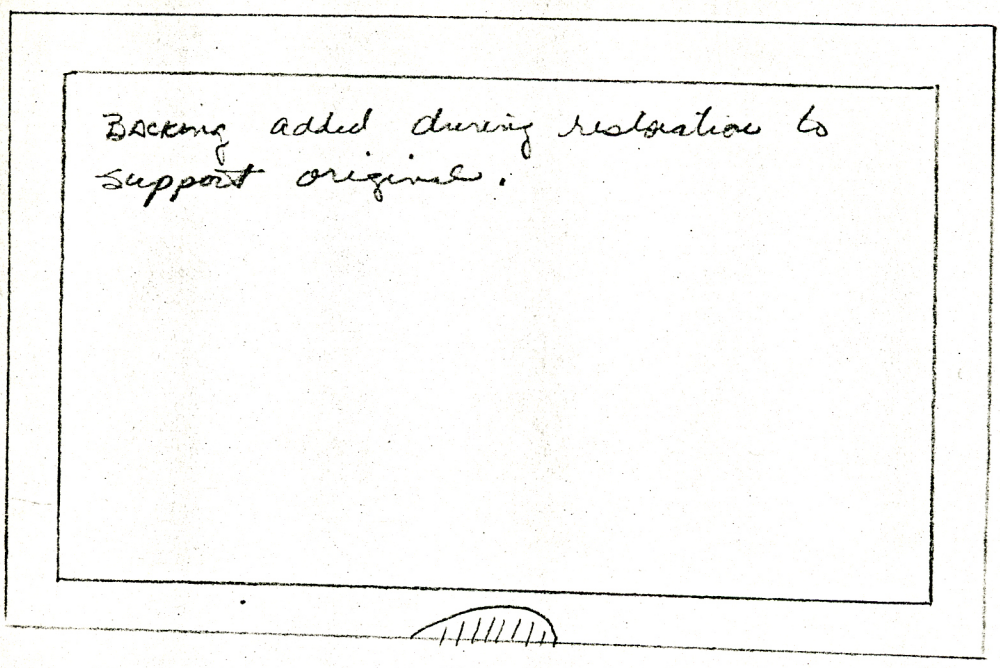
REVERSE

General: Poor
Specific: The field is replaced with a supportive fabric.

//// = missing
