Textile Preservation Associates, Inc.

TREATMENT REPORT

TPA No. 1105
Object Galveston 2nd Nat'l.

Client Texas State Archives
P. O. Box 12927
1201 Brazos Street
Austin, TX 78711-2927

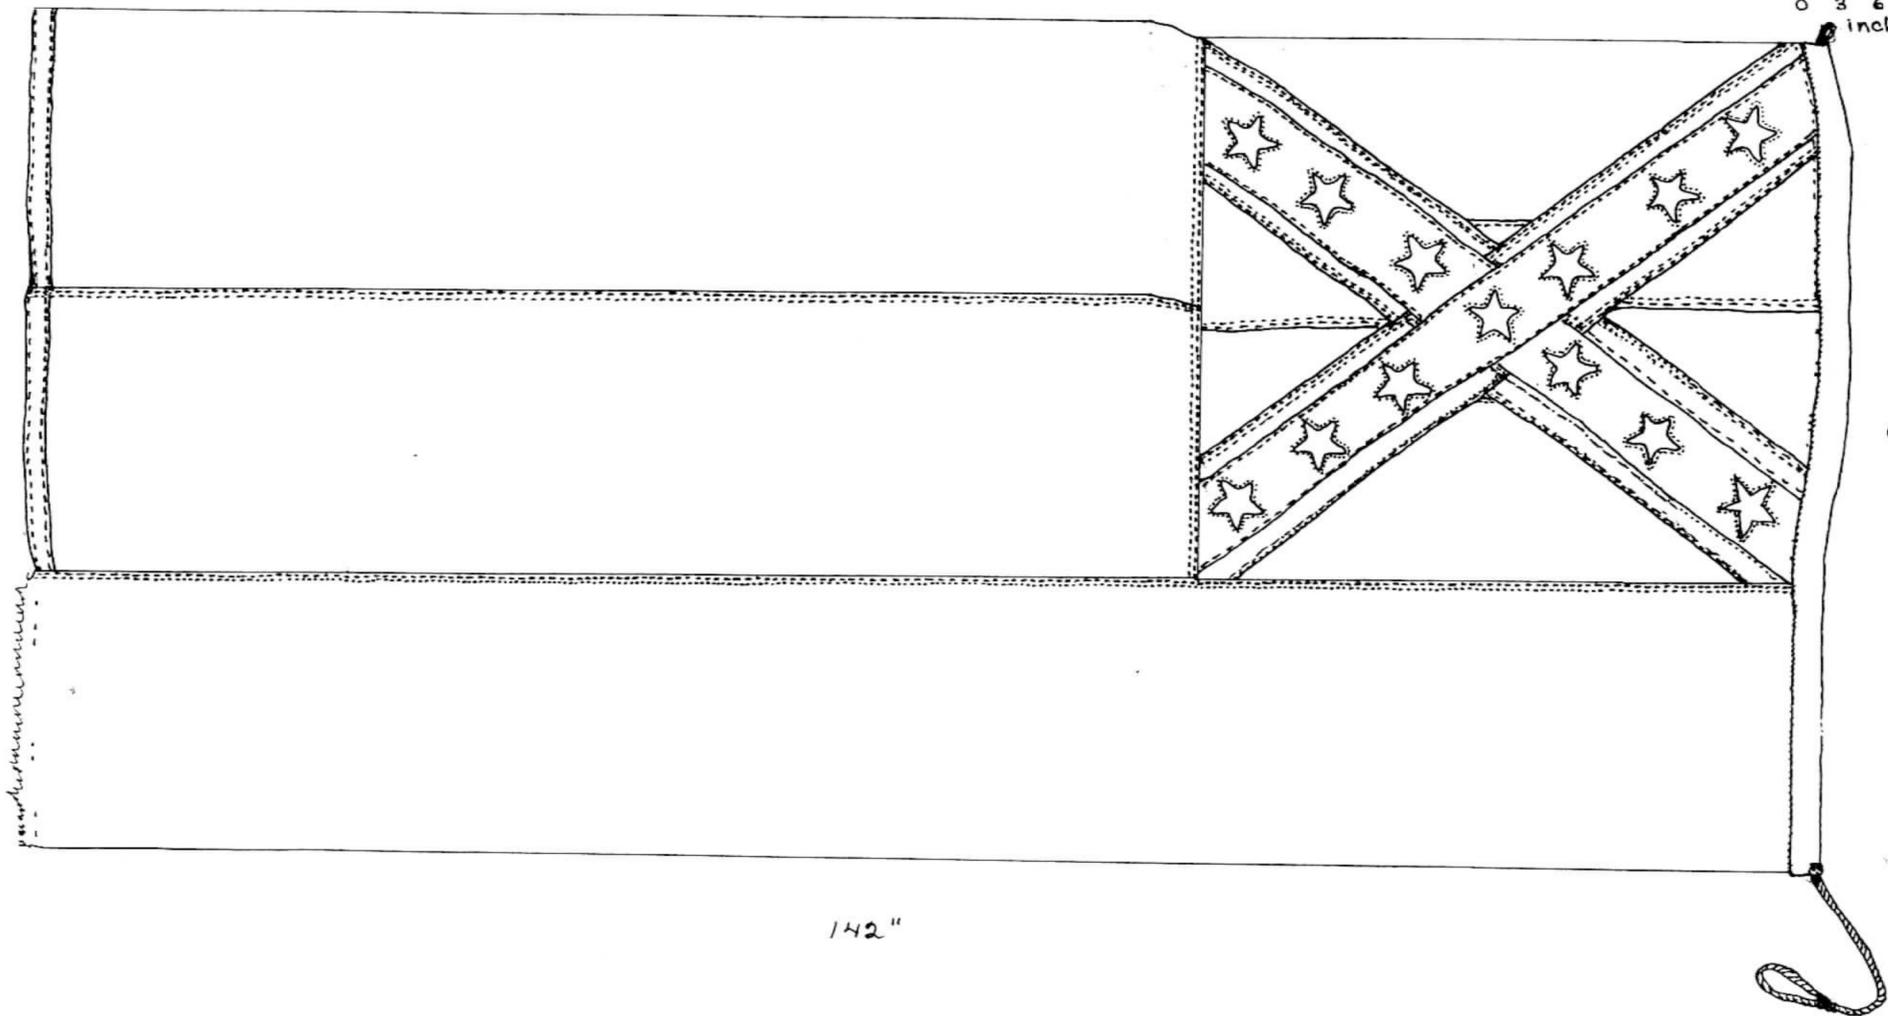
Drawing No: 3 Condition

The flag is intact except for a 1" section of the hem on the fly end of the bottom bar. There is a 3" x 4" hole in the center of the fly near the bottom seam and a 2" square hole along the top edge 2" from the canton. There is a 1" x 2" hole on the top edge of canton and another hole in the bottom quadrant of canton. There is a series of smaller holes along the center of the top edge and in the center of the fly. The flag is extremely soiled throughout. The wool is brittle and degraded. The hoist edge has a 1" burn hole in the center.

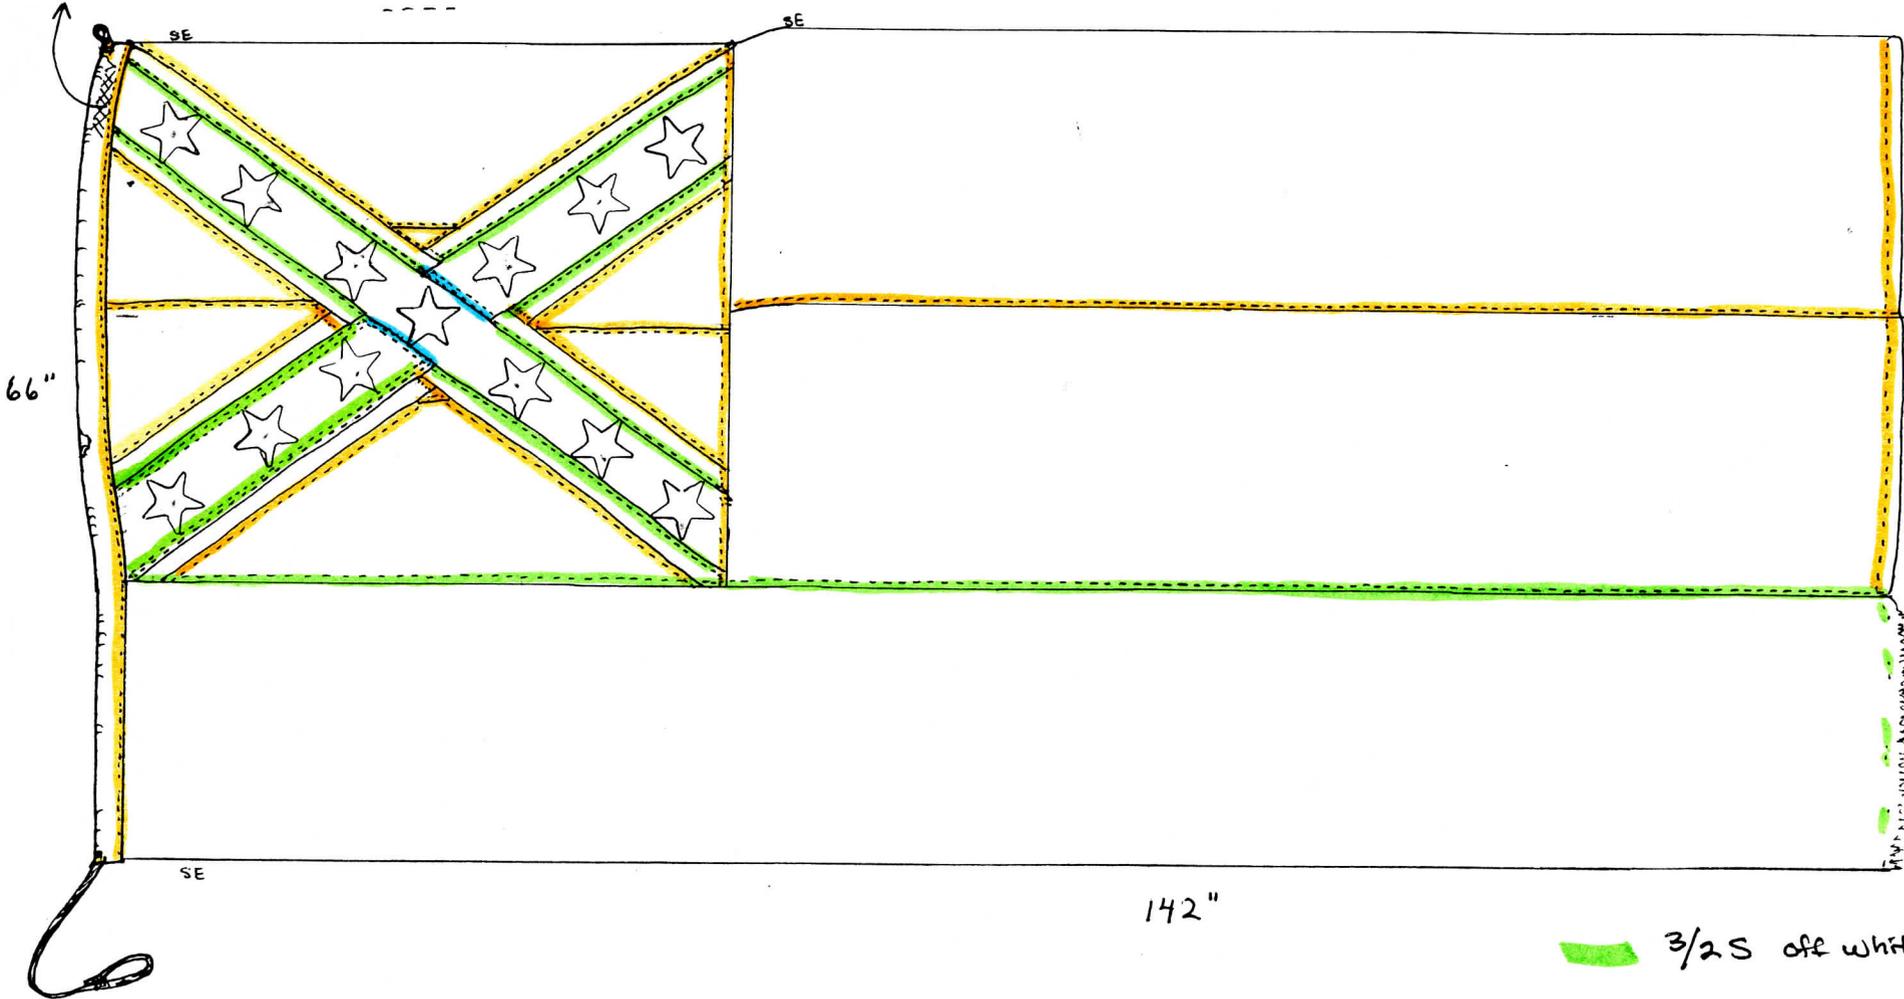
Drawing No: 8 Sewing Threads

- 3/2 S off white cotton
- 2 S tan linen
- 3 S off white cotton
- 3/2 S brown cotton
